**National Highway
Traffic Safety
Administration**

ODI RESUME

Investigation: PE 16-007
Date Opened: 06/28/2016
Investigator: Kareem Habib
Approver: Stephen Ridella
Subject: Automatic vehicle control systems
Date Closed: 01/19/2017
Reviewer: Jeff Quandt

Manufacturer: Tesla Motors, Inc.
Products: MY2014-2016 Tesla Model S and Model X
Population: 43,781
Problem Description: The Automatic Emergency Braking (AEB) or Autopilot systems may not function as designed, increasing the risk of a crash.

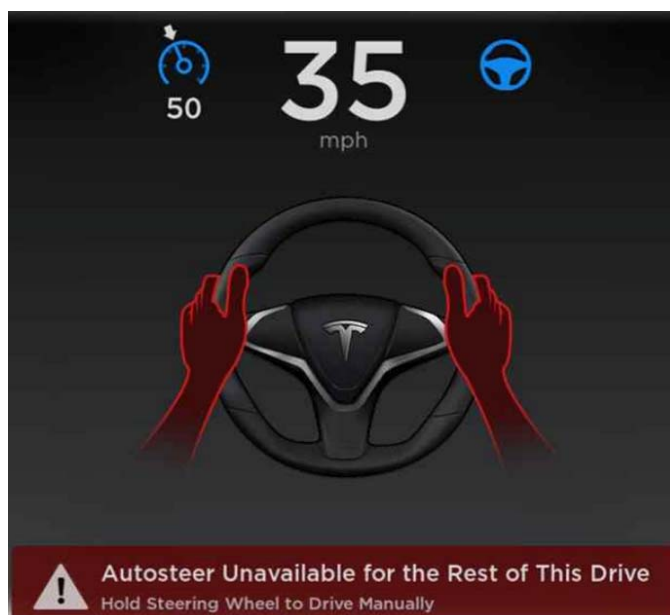
Figure 6. Autosteer "Strike-Out" Alert.

As part of Tesla's 8.0 over-the-air (OTA) software update in September 2016, Tesla revised the timing of the hands-on warnings and added a feature that takes away the Autopilot driving feature for the remainder of the drive cycle if the driver fails to respond to the alerts adequately (known as an "Autopilot strikeout" – Figure 6).

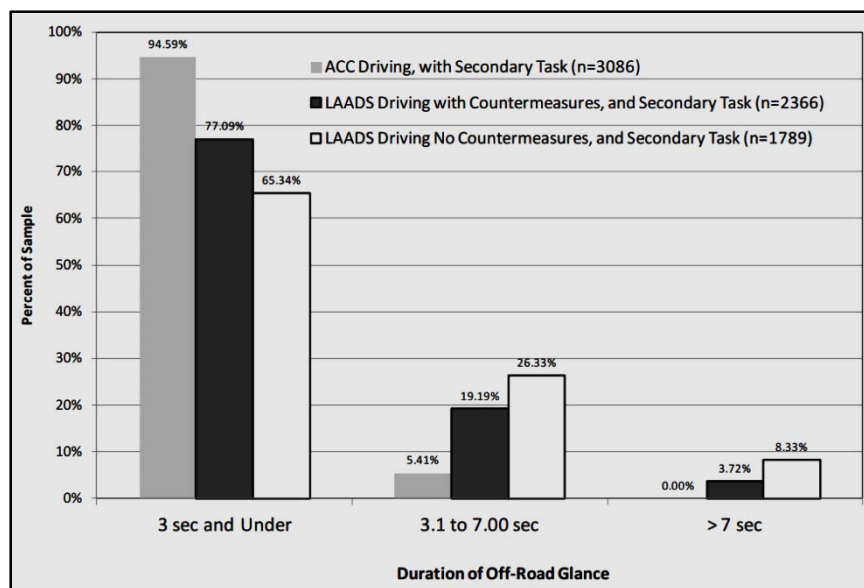
Figure 10. Percentage of Off-Road Glances Across Driving Mode for Short, Intermediate and Long Time Bins.

5.3 Driver distraction. Figure 10 shows the distributions of off-road glances by duration that were observed in a research study by General Motors of driver behaviors in vehicles with Limited-Ability Autonomous Driving Systems (LAADS)¹⁷ when operated in SAE Level 1 and Level 2 modes.¹⁸ The data show distractions occur in each operating mode and that the majority occur for 3 seconds or less when driving in ACC mode or with ACC and Lane Centering Control used together. ODI's analysis of field incidents found that most of the crashes developed in less than 3-4 seconds. Distractions greater than seven seconds, such as appears to have occurred in the fatal Florida crash are uncommon, but foreseeable.
